**A RESOLUTION OF THE COUNCIL OF THE CITY OF RICHMOND, CALIFORNIA,  
ACCEPTING THE KELLER BEACH SANITARY SEWER CCTV REVIEW AND  
ASSESSMENT REPORT FOR THE CITY OF RICHMOND PREPARED BY  
NCE-COASTLAND, DATED JANUARY 3, 2022**

**Date:** January 3, 2022  
**To:** Andre Jadcowski, P.E., NCE  
**From:** Jenny Melman, P.E.,  
NASSCO PACP Cert. U-0819-70306761  
**Subject:** City of Richmond  
Keller Beach Sanitary Sewer CCTV Review  
and Assessment Report

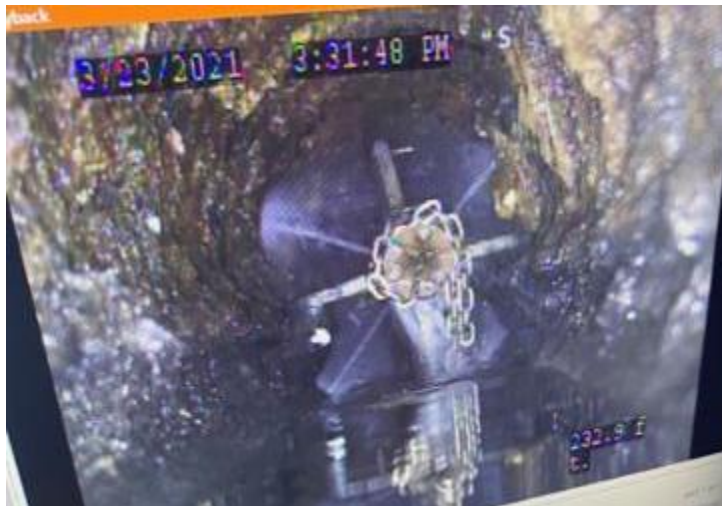
*Figure 1. View of Keller Beach sewer pipe prior to cleaning. Hydro nozzle is in use. Chain flail is in view.*

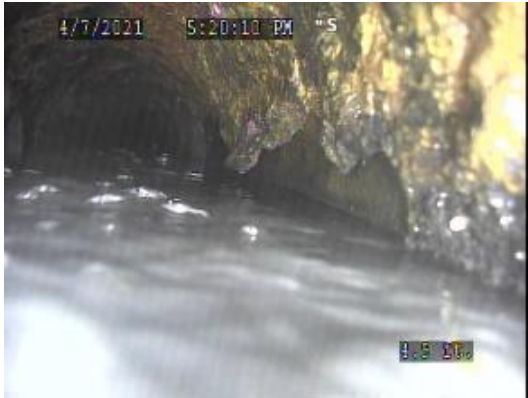
CO Q-8 to MH Q-9

According to Express Sewer, the entire reach of Keller Beach sanitary sewer was extremely corroded prior to cleaning. As shown in the post-cleaning images below, the upstream reach of pipe (MH Q-17 to MH Q-25) was generally descaled, while further downstream (MH Q-1 to MHQ-17) extensive turberculation and wall roughness remains.

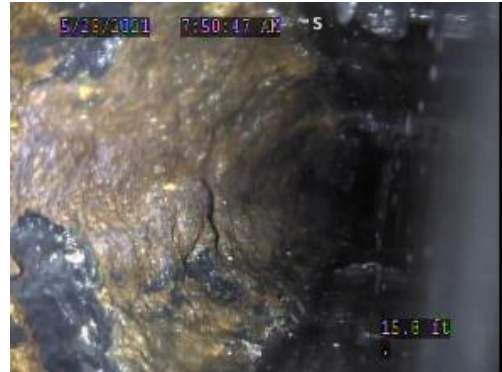
MH Q-14 to MH Q-15

- **Sand Deposits:** Much of the pipeline was observed to have substantial sand deposits. Several pipe segments, particularly between MH Q-14 and MH Q-16, were essentially choked full of sand. Considerable effort was required to remove sand and clean the pipe prior to performing a video inspection. Some segments of pipe refilled with sand within the two-week period between the time of cleaning and the next suitable tide condition when crews returned to complete the video inspection, and needed to be cleaned again. The presence of sand in the sewer main is evidence of the presence of holes or defects in the upstream collection system (either the sewer main, laterals, manholes or cleanouts). Another contributing source of sand and I&I was MH Q-14 which was discovered to have no manhole cover (the manhole cover has since been replaced).

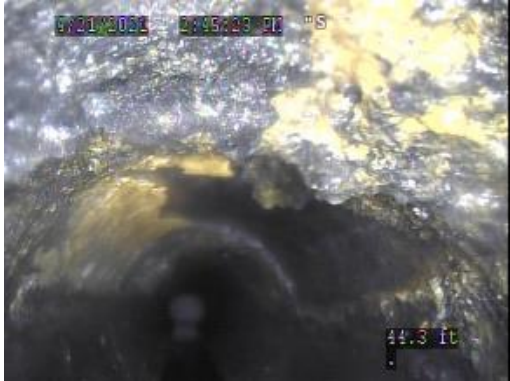
MH Q-15 to CO Q-16

MH Q-15	CO Q-16	US	252	15	6%	10	CI	Unknown: No pipe visual	Inspectors unable to drawdown water due to reverse setup; Camera underwater 0-15'+; Severe sag	Start at MH Q-15; Did not reach CO Q-16;	No visual due to high water; Inspection abandoned at 15'; Could not drawdown water due to poor access conditions from CO;
CO Q-16	MH Q-17	DS	207	208	100%	10	CI	Significant/Severe roughness observed	Water level 5-50%; Moderate to severe sags	Start at MH Q-17; Lateral at 188.1'; Bend at 206'; Ended at CO Q-16	Good pipe visual; Difficulty passing bend in pipe
MH Q-17	CO Q-18	DS (reverse)	246	246	100%	10	CI	Pipe visual is poor; Where pipe is clear, pipe appears to be fully descaled. Evidence of significant pipe corrosion, especially top half of pipe.	Water level 5-100% Severe sags (camera underwater) last third of pipe up to MH Q-17	Start at MH Q-17; Push cam to CO Q-18; Pull back with hydronozzle; Ended at CO Q-18	Poor pipe visual; rapid/shaky footage; only one side of pipe in view; no stills to inspect pipe condition; distance meter not working

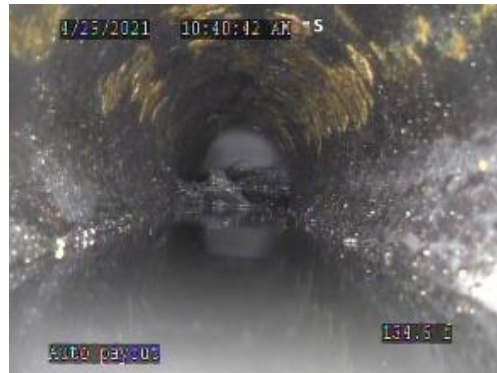
CO Q-18 to MH Q-19

CO Q-18	MH Q-19	US (reverse)	185	185	100%	10	CI	Pipe walls are fully descaled after cleaning. Rough wall surface.	Pipe holds water, may be due to sags. Water level 10-20% in reverse footage	Start at MH Q-19; Push cam to CO Q-18; Pull back with hydronozzle; 2 laterals observed; Ended at MH Q-19	Pipe inspected in reverse. MH Q-19 appears to be possible source of I/I and should be inspected.
MH Q-19	CO Q-20	DS	201	201	100%	8	CI	Pipe walls are fully descaled after cleaning. Rough wall surface.	Water level 5-100% Severe sags (camera underwater)	Start at CO Q-20; Push cam to MH Q-19; Pull back with hydronozzle; 1 lateral observed at 5'; Ended at CO Q-20	Push cam operated in reverse. Poor visual: rapid/shaky footage; no stills to inspect wall condition
CO Q-20	CO Q-22	US (reverse)	273	273	100%	8	CI	Rough wall surface. Pipe walls are fully descaled after cleaning. Poor visual (blurry and rapid return footage)	Low water level in most of reverse footage due to hydronozzle. Severe sags; Camera underwater 206'-226'	Start at CO Q-22; Ended at CO Q-20; Pull back with hydronozzle; Ended at CO Q-22	Push cam operated in reverse. Poor visual: rapid/shaky footage; no stills to inspect wall condition

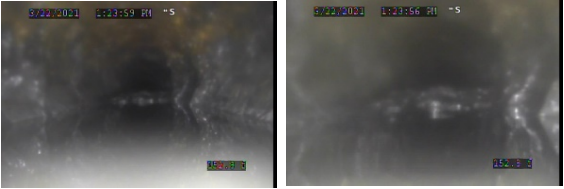
131.2	MGO		cam stationary, difficulty moving	
152.8	OBZ	03-09	no forward progress from here (51:30 to end of video)

152.8	MSA		Survey abandoned
