**A RESOLUTION OF THE COUNCIL OF THE CITY OF RICHMOND, CALIFORNIA,  
ACCEPTING THE KELLER BEACH SANITARY SEWER CCTV REVIEW AND  
ASSESSMENT REPORT FOR THE CITY OF RICHMOND PREPARED BY  
NCE-COASTLAND, DATED JANUARY 3, 2022**

**Date:** January 3, 2022  
**To:** Andre Jadcowski, P.E., NCE  
**From:** Jenny Melman, P.E.,  
NASSCO PACP Cert. U-0819-70306761  
**Subject:** City of Richmond  
Keller Beach Sanitary Sewer CCTV Review  
and Assessment Report

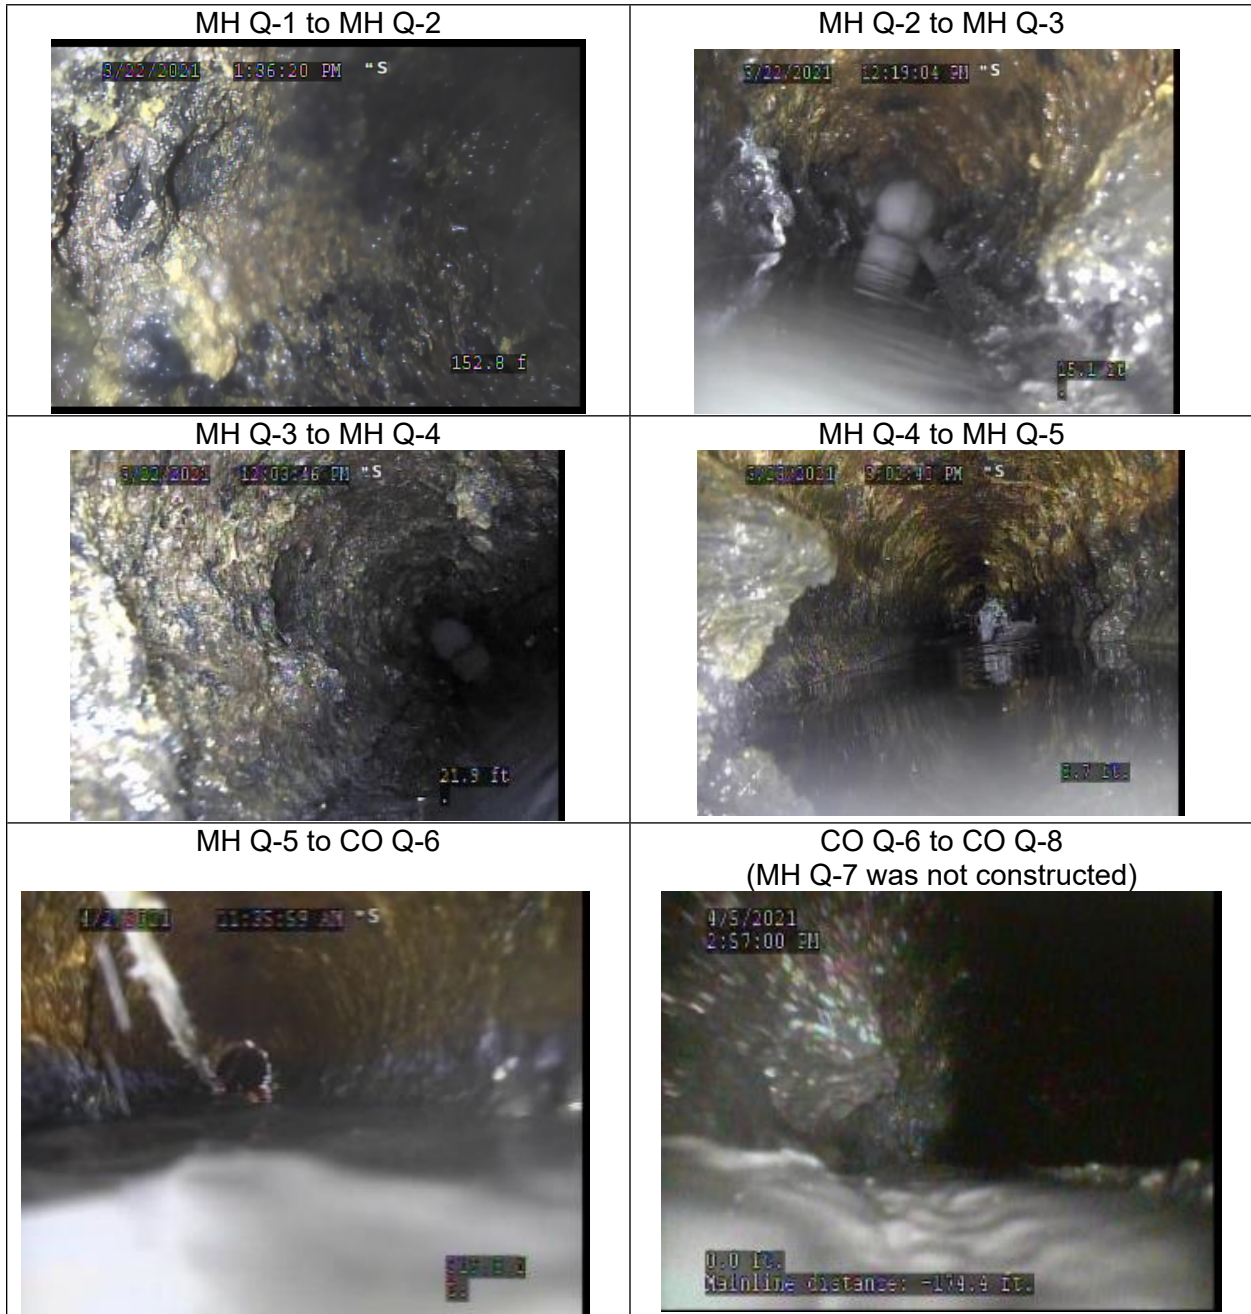
CO Q-8 to MH Q-9

According to Express Sewer, the entire reach of Keller Beach sanitary sewer was extremely corroded prior to cleaning. As shown in the post-cleaning images below, the upstream reach of pipe (MH Q-17 to MH Q-25) was generally descaled, while further downstream (MH Q-1 to MHQ-17) extensive turberculation and wall roughness remains.
